# **INDOOR AIR QUALITY ASSESSMENT**

**Adams Town Hall  
8 Park Street  
Adams, Massachusetts**

Prepared by:  
Massachusetts Department of Public Health  
Bureau of Environmental Health  
Indoor Air Quality Program  
March 2008

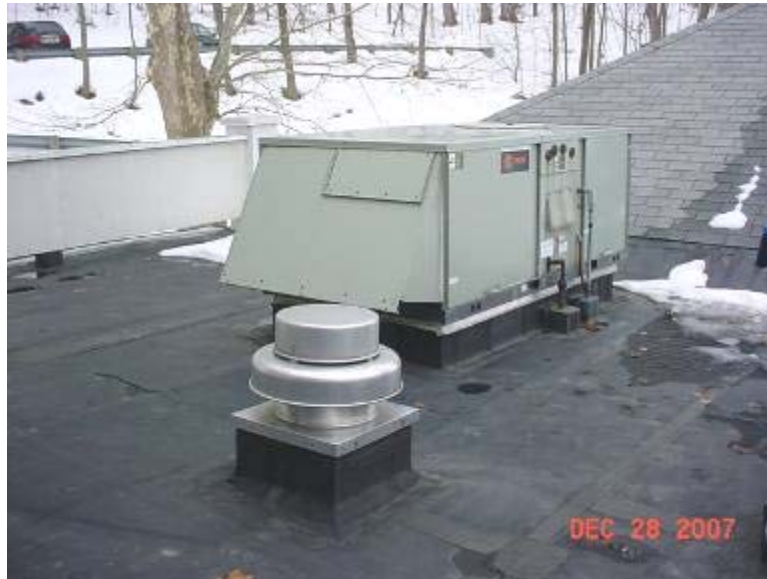
**Picture 1**

- **1996 Wing:** The HVAC system for the 1996 wing is located on the roof (Picture 1). This AHU does have a fresh air intake; however, it lacks a means of exhaust. It appears that exhaust ventilation was intended to be provided by bathroom vents. A bathroom exhaust vent was situated in close proximity to the fresh air intake for this AHU on the roof of the building. The building code requires that pollutant sources must be ten feet away from or two feet above fresh air intakes (BOCA, 1993, SBBRS, 1997). An extension several feet above the fresh air intake may be needed to prevent sewer gas from entering the AHU and distributed within the wing (called entrainment).

**AHU for 1996 Wing, Note Exhaust Vent in Foreground**

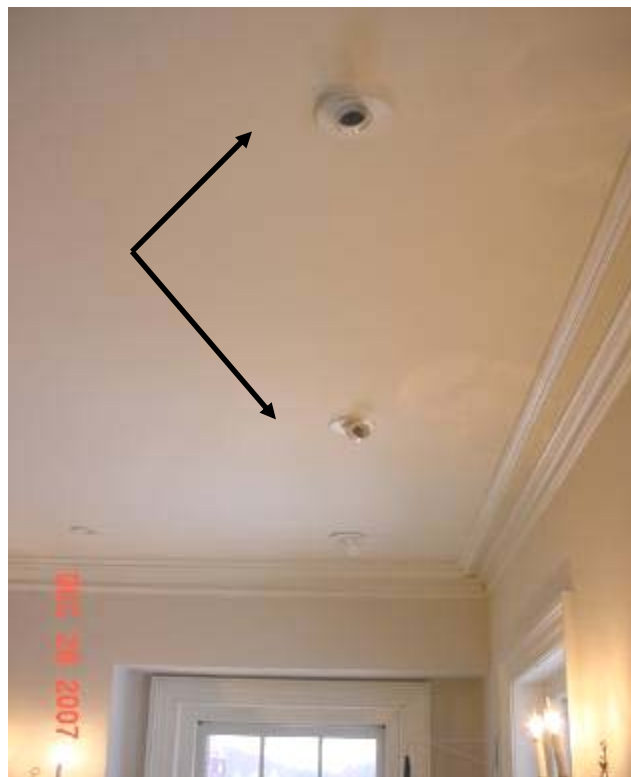
**Picture 2**

Please note that a number of occupants of the 1907 wing reported poor temperature control. These offices were provided fresh air supplies that consist of holes in the ceiling of each room that is roughly the diameter of PVC drain pipe (Picture 2). In each room with cold complaints, there were fireplaces that were originally used to heat rooms of the mansion. All of the fireplaces had either open (Picture 3) or slightly open flues, which allows cold air to enter these rooms. In addition, when retrofitting a building with an AHU with air-conditioning capability, pathways of hot, moist air in summer must be sealed to prevent condensation, which can provide a source of mold growth. Each fireplace chimney, with flues in the condition described, is equivalent to having an open window while operating air-conditioning. It is customary to seal chimney at both ends to prevent water accumulation and hot, moist air penetration if a mechanical air condition system is installed and fireplaces are not in use.

**Fresh Air Diffusers, 1907 Wing**

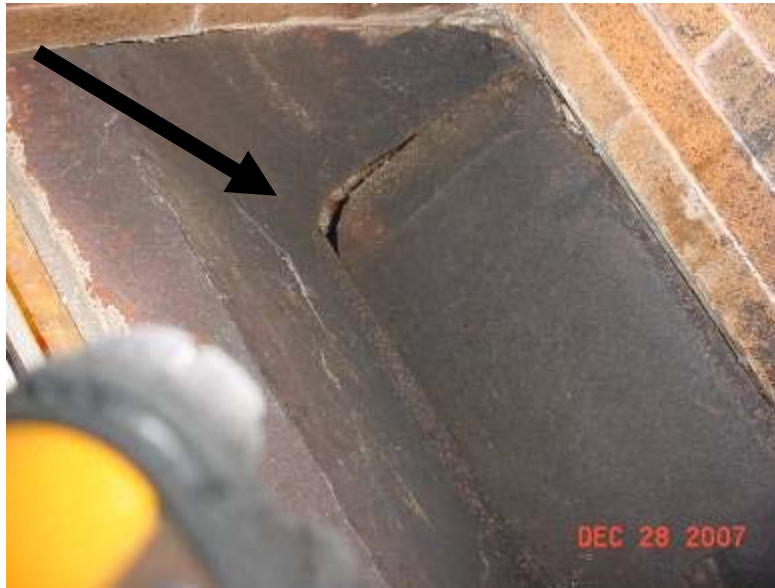
**Picture 3**

**Fire Place Flue, Note Space**

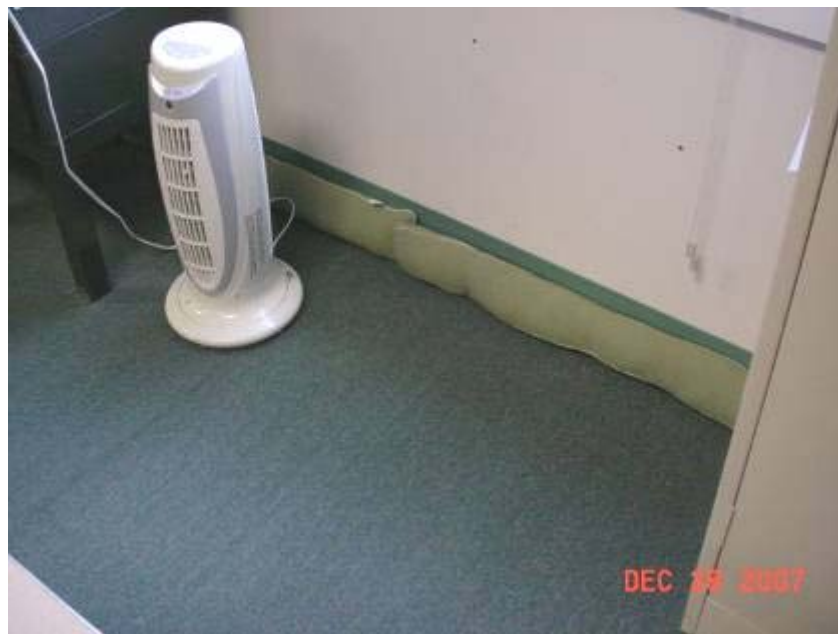
**Picture 4**

Also of note was the use of draft excluders along the baseboard of the 1996 wing east wall (Picture 4). An examination of the foundation wall found a number of areas that were

sealed using a sealant compound, rather than flashing. The areas where sealant was damaged or missing roughly corresponds with the draft excluders; therefore, outdoor air may enter this section of the building through these breaches.

**Draft Excluders along the Baseboard of the 1996 Wing**

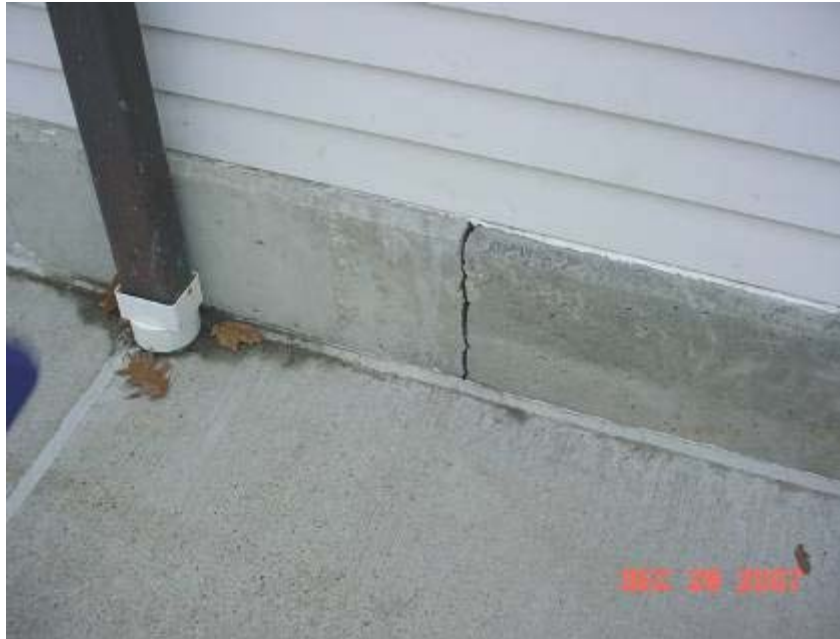
**Picture 5**

- Ground around the southwest corner was removed, exposing the flat stone foundation (Picture 5). Rock was added around the base of the foundation wall. No drainage could be identified in the rock;
- Parget (a cement mixture used to waterproof exterior surfaces) was applied to the outer face of the stone foundation to provide water proofing (Picture 6). This material was either missing or unevenly applied, likely providing minimal water proofing.
- A door was added to provide an exit from these offices to the outdoors (Picture 7); moisture sampling of the door threshold, doorframe and surrounding gypsum wallboard (GW) were found moistened. The last previous significant rain in the greater Adams area

**Space in Sealant of Outer Wall opposite Draft Excluders along the Baseboard  
of the 1996 Wing**

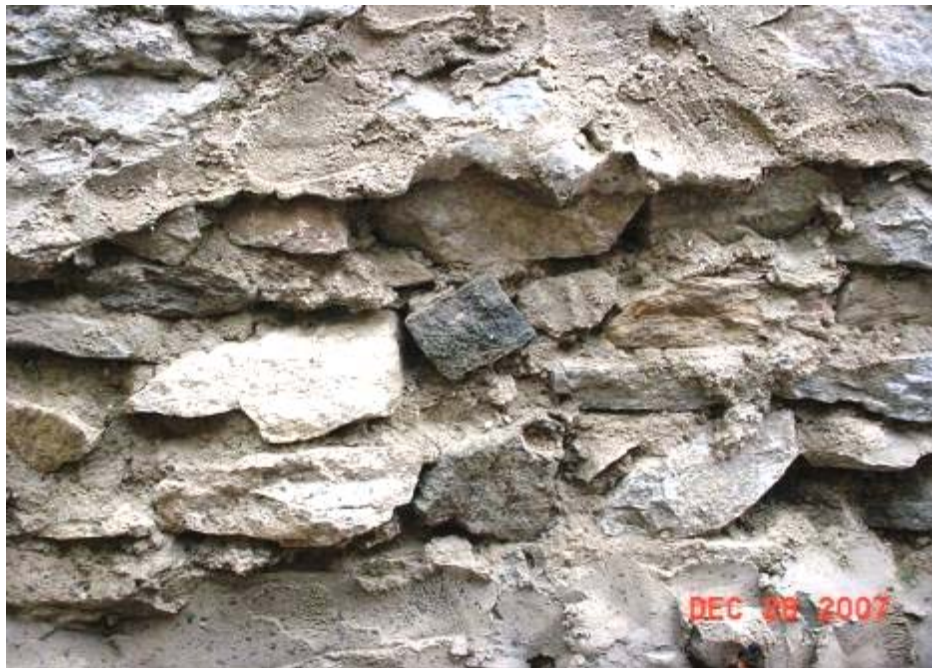
**Picture 6**

**Parge was Applied to the Outer Face of the Stone Foundation,  
Note Seams in Wall**

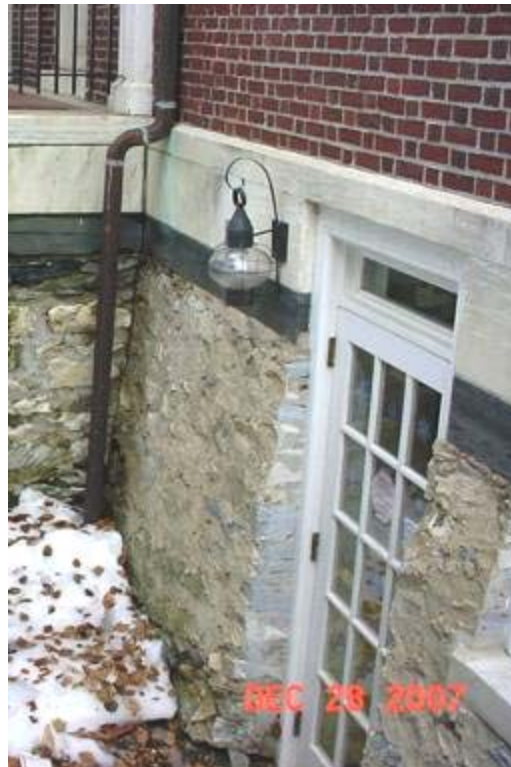
**Picture 7**

**Door Added to Foundation**

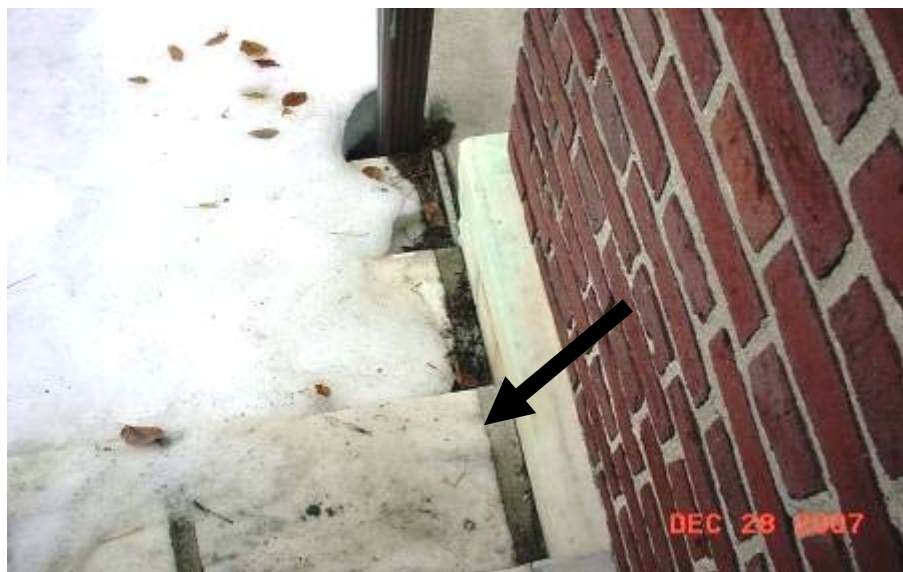
**Picture 8**

**Seam between Wall and Stair above Building Inspector's Office**

7. Examine the exterior wall of the 1907 wing breaches. Seal these opening with an appropriate sealant.
8. Seal the seam between the outside step and the building as depicted in Picture 8 with an appropriate sealant.

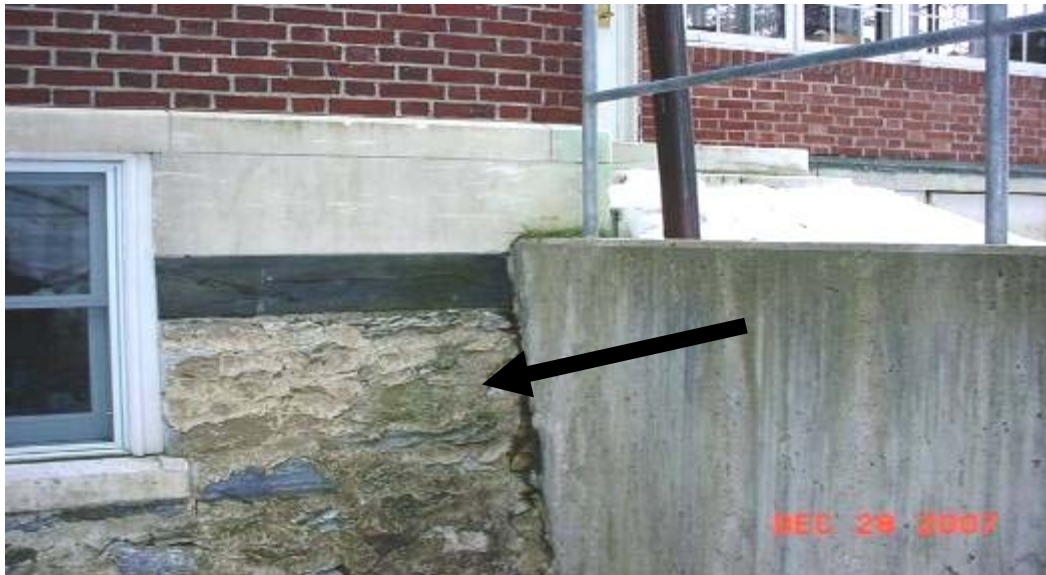
**Picture 9**

Repeated episodes of musty odors were reported in the southwest corner of the Board of Health/Building Inspector's Offices. GW in this location had elevated moisture content when compared to other interior wall locations (Table 2). These results indicate that either rainwater is penetrating through the foundation [likely a seam in a stairway above this location that does not have a downspout (Picture 8)] or through the exposed, pargeted foundation wall (Picture 9). In either instance, reinstallation of GW and use of carpeting in these areas without remediating the conditions creating the moisture accumulation will likely lead to further moisture accumulation and musty odors. In addition, a water cooler located on carpeting was noted in one office space. The carpet below the water dispensing nozzles can become moistened by use of the cooler. Porous materials that are wet repeatedly can serve as media for mold growth.

**Exposed, Pargeted Foundation Wall outside Building Inspector's Office,  
Note Dampness on Wall**

1. GW should be removed from all areas attached to the targeted exterior wall in the 1907 wing basement level. The exterior walls in this area should be examined by a mason for the best methods to be used to reduce water penetration through the foundation section.

GW should not be reinstalled. If the interior wall is replaced, consider using a material that does not contain paper or other materials that can sustain mold growth.

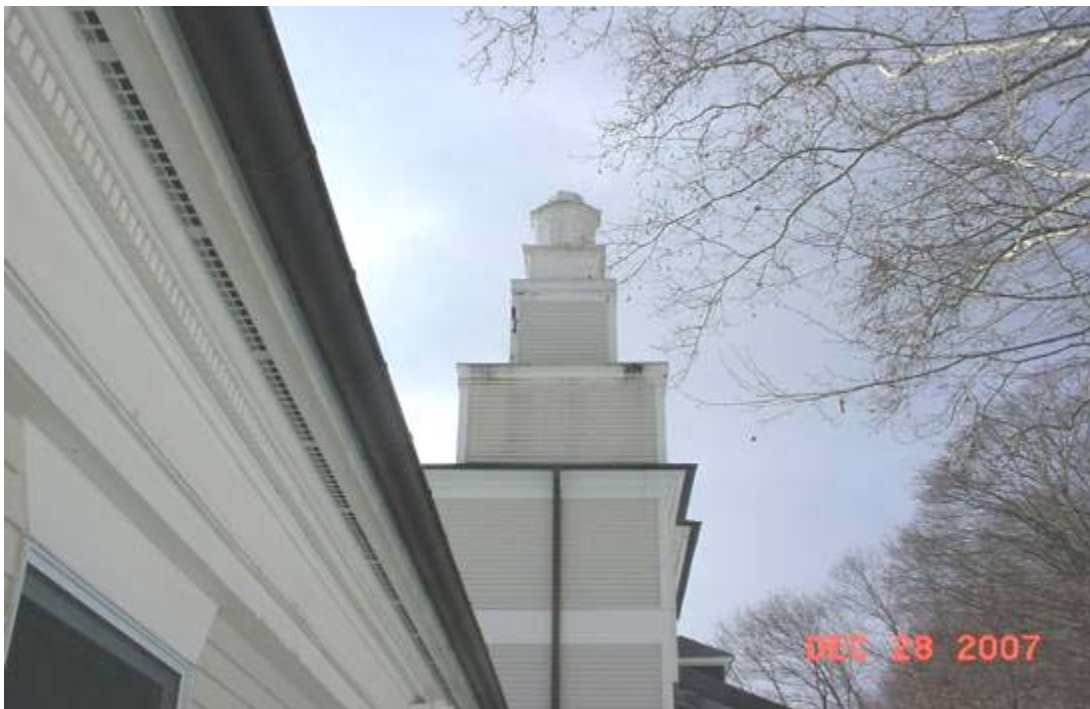
**Picture 16**

of rainwater (Pictures 10 through 15). The clock tower at the ATH is in the shape of a tall ziggurat, with roof surfaces perpendicular to the walls of the tower (Pictures 16 and 17). This design allows for rainwater to accumulate on the small horizontal roofs created by the design, which then exposes the vertical sections of the roof to rainwater, which takes the form of rotted wood (Pictures 17 through 19). This significant amount of water is directed onto the flat roof above the 1996 wing rest rooms, which has neither a roof drain or gutter/downspout system. Gutters and downspouts are needed to direct rainwater from exterior walls to prevent rot and eventual leaks inside the building. Other areas around the roof edge without gutters showed similar signs of water damage.

**Adams Town Hall Clock Tower, Note Ziggurat Pattern of Flat Horizontal Roofs  
(as well as rotted wood beneath each flat roof)**

6. Examine the feasibility of adding gutters to the roof edges of the clock tower to reduce water damage. Replace water damaged wood once gutters are in place.

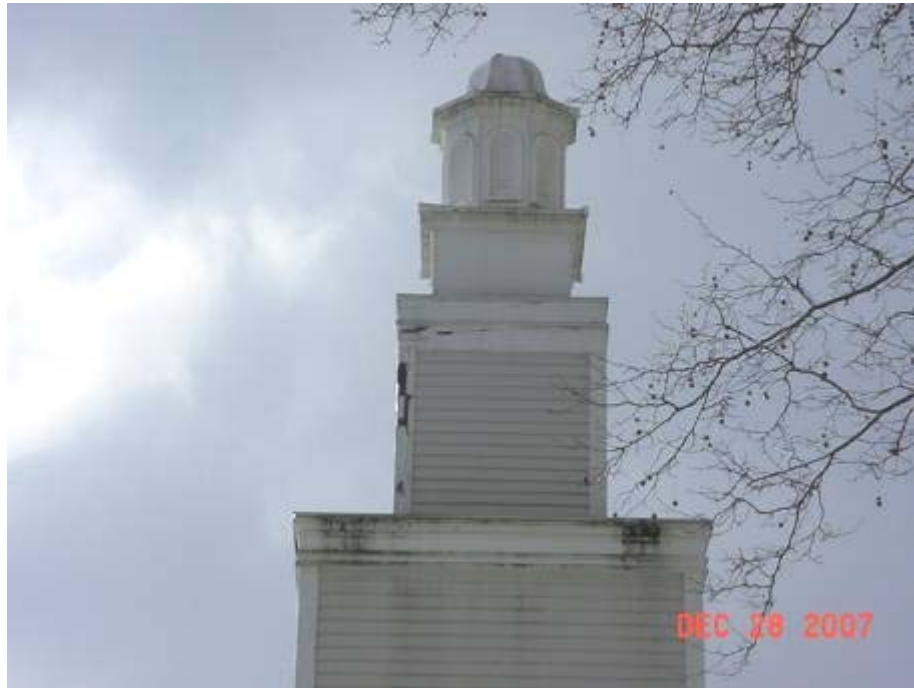
**Picture 17**

**Close-Up of Damage to the Adams Town Hall Clock Tower**

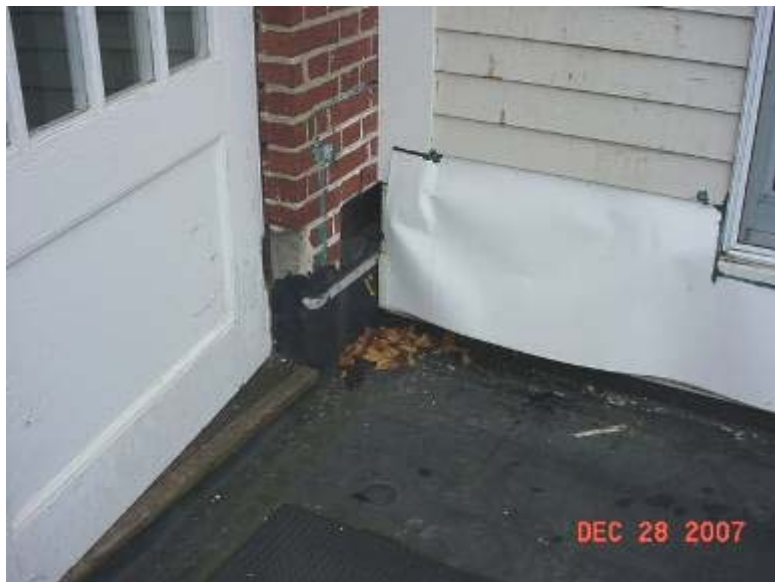
**Picture 18**

**Water Damage to Exterior Wall of Adams Town Hall Clock Tower  
(sheet metal covering rotted clapboard)**

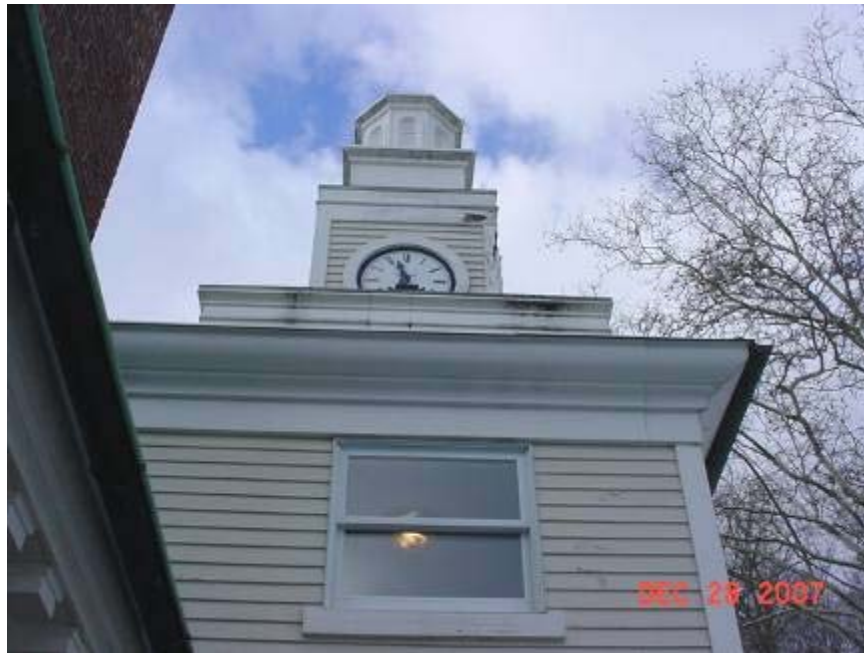
**Picture 19**

**Water Damage to Exterior Wall, Adams Town Hall Clock Tower**

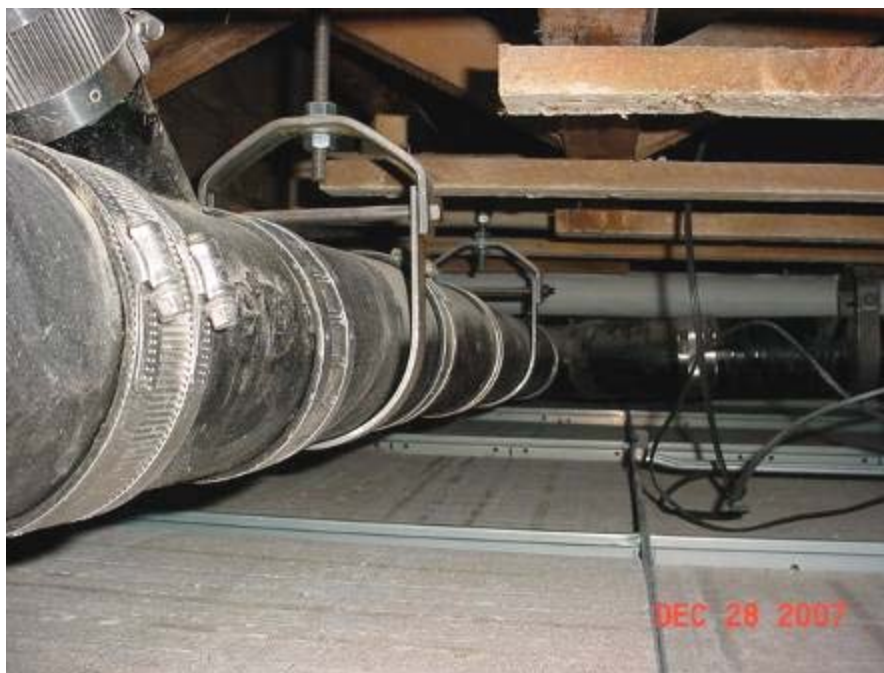
**Picture 20**

Above the ceiling in the basement office Room 302, BEH staff observed a horizontal run of drain pipe that was pieced together with a minimum of 17 separate rubber gasket screw clamps within an 8 foot span (Picture 20). Rubber gasket screw clamps are used to join drain pipes, but are preferred for use in vertical runs of drain pipe because it is less likely that the gasket material would be continuously exposed to liquid. It is preferable that horizontal runs of drain pipes be continuous with as few joints as possible with the joints installed in a watertight fashion. In the experience of BEH staff, rubber gasket screw clamps are prone to developing openings that allows for liquids and air to escape from the drain pipe joint. This condition may occur due to degradation of the rubber, loosening of the clamp, degradation of pipe material or shifting of pipes due to building settling. A licensed plumber should be retained to examine and if necessary, repair the drain lines in the room, ensuring that no leaks and/or sewer gasses are allowed to enter the office space. Please be advised that the plumber is required by the State Plumbing Code to obtain a permit prior to commencing work on the system.

**Drain Pipe above Room 302 Suspended Ceiling, Note 6 Gaskets/Clamps in Picture**

4. Consider consulting a licensed plumber concerning the drain system above room 302.
5. Examine the feasibility of extending the basement HVAC system to include room 302.

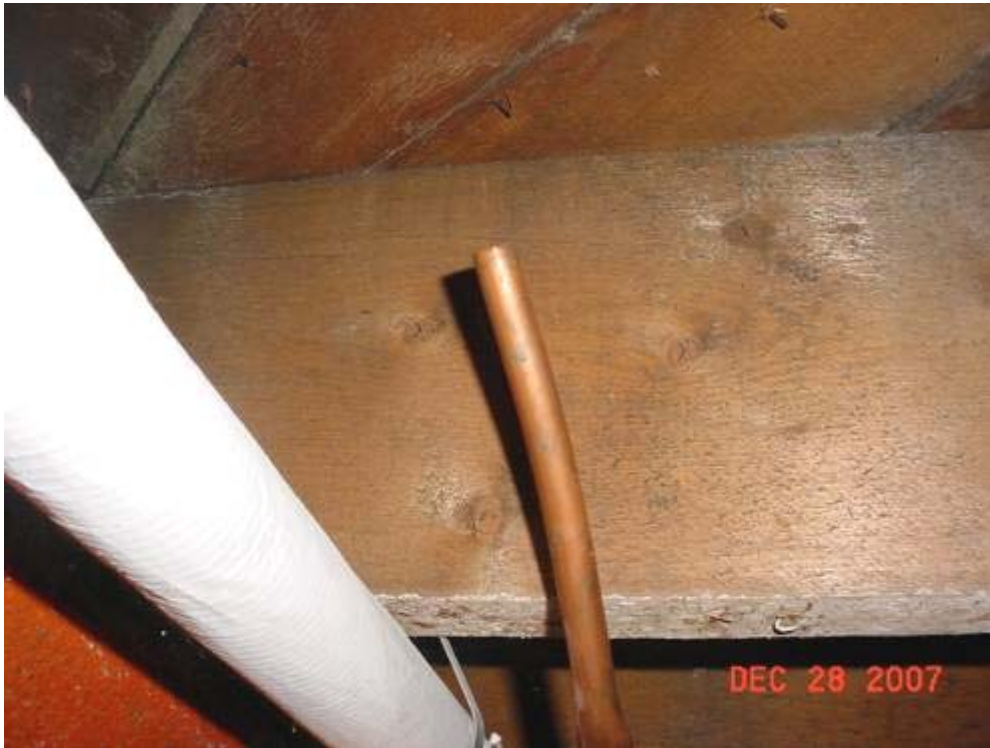
**Picture 21**

- **Community Development Office (B 16 – inner room on left):** When ceiling panels were lifted by BEH staff, a noticeable movement of air was observed above the ceiling tiles, indicating pressurization of the ceiling plenum. The ceiling plenum in this building should be pressure neutral since it is not part of the HVAC system. This pressurization is likely the result of breaches or damage to the exterior wall in this area that requires repair. Additionally, a copper pipe of unknown purpose was found open above ceiling tile in this room (Picture 21). Pipes should be properly sealed if abandoned.

**Open Pipe above Room B-16 Office**

All wall holes and pipe should be sealed to eliminate pathways for odors and particulates to move between rooms.
